Septodont Case Studies *Collection*

No. 05 - June 2013

BIODENTINE™

Biodentine™, a promising bioactive material for the preservation of pulp vitality in restorative dentistry

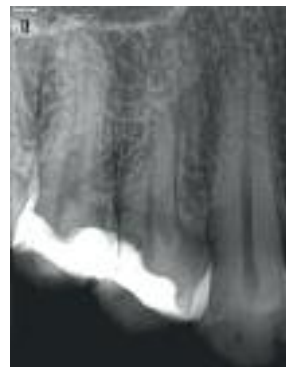
Fig. 1: Preoperative radiograph showing recurrent caries below existing amalgam restorations in teeth # 14 and 15

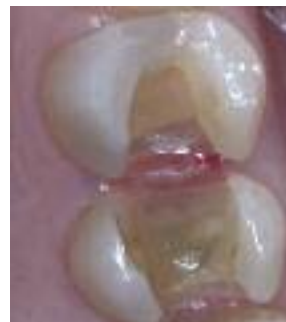
Fig. 3: Clinical picture after caries removal

After patient consent, local anesthesia was performed (Articaine HCL 4% and 1:200000 adrenaline, Ubistesin, 3M ESPE), the amalgam restorations were removed and the carious dentin was completely excavated (*Fig. 2*). At the proximal cavity area of tooth # 15 a very thin pulp facing layer of remaining dentin could be observed (*Fig. 3*). Biodentine™ (Septodont) was chosen as a provisional filling material of the entire cavity of both teeth (*Fig. 4, 5*). The material was handled according to the manufacturer's

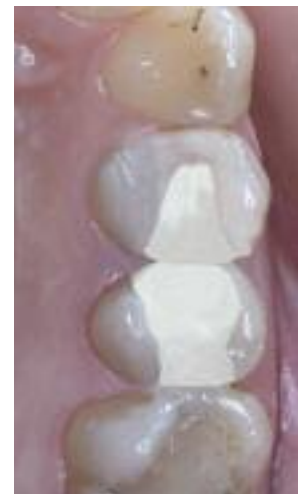
Fig. 4: Biodentine™ was placed as a bulk material to restore both cavities and left in place for 6 weeks. The material has a smooth surface after setting.

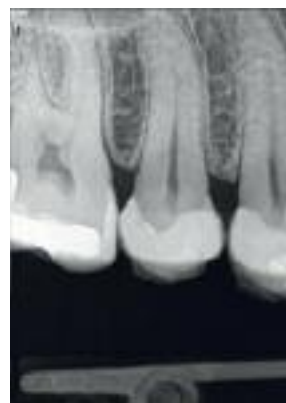
Fig. 5: Radiograph after Biodentine™ placement.

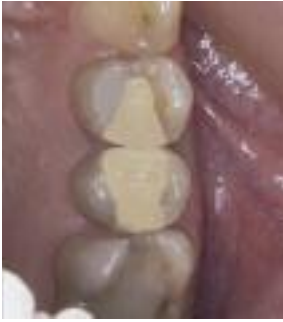
Fig. 6: Biodentine™ restorations 6 weeks after placement. Marginal integrity of both restorations was fully preserved and no fractures were observed. A slight discoloration of both restorations could be recorded.

eliminated while preserving pulp vitality (*Fig. 6*). The patient reported that she remained symptom-free during the six week period, whereas both teeth were positive on CO₂ snow sensitivity and negative on percussion. Biodentine™ was then partially removed to serve as a cavity liner (*Fig. 7*) and both teeth were restored with indirect composite restorations. Briefly, after final cavity preparation with Biodentine™ remaining as a dentin substitute, final impression was taken using a one-phase polyether material (Impregum, 3M ESPE) (*Fig 8, 9*). The teeth were restored with composite inlays (SR Adoro, Ivoclar Vivadent) that were cemented with a dual cure resin cement (Variolink II, Ivoclar Vivadent) (*Fig. 10*). At the follow-up visit at 6 months and 1 year after treatment (*Fig. 11 A, B*) both teeth were free from any symptomatology and again tested positive for sensitivity and negative for percussion. Radiographical examination showed no signs of periapical pathology (*Fig. 11 B*).

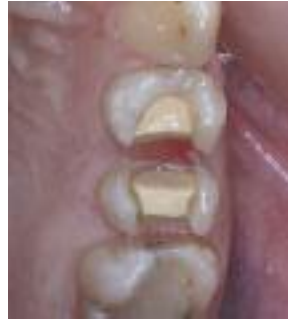
Fig. 7: Biodentine™ was partially removed to serve as a dentin substitute.

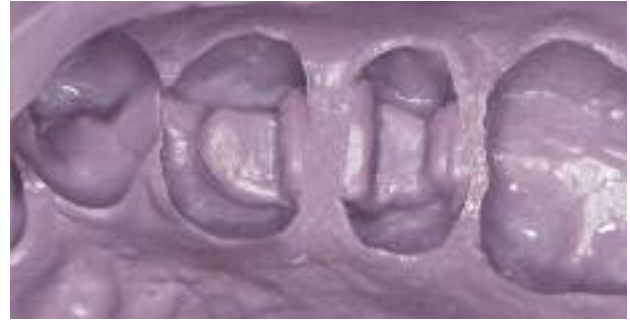
Fig. 8: Final impression with one-phase polyether material.

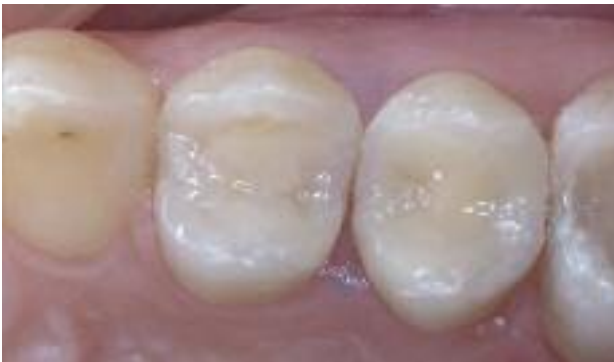
Fig. 10: Final inlay restorations in place cemented with a dual cure resin cement.

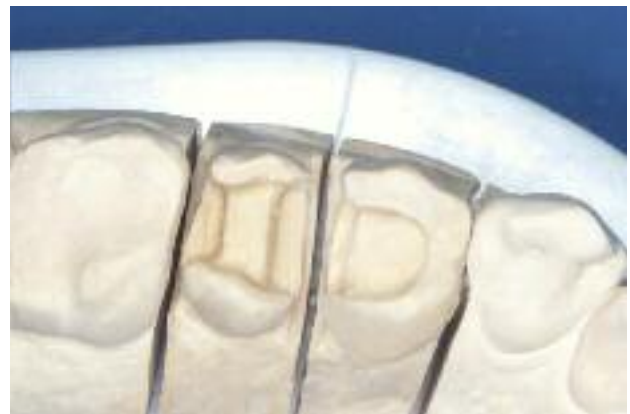
Fig. 9: Final cast for the inlays build up with a laboratory composite.

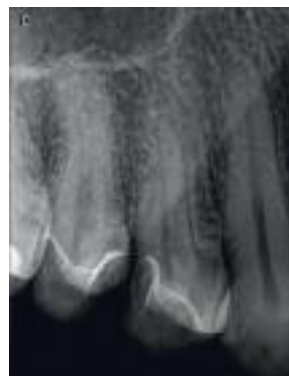
Fig. 11: A, B Radiograph A. six months and B. 1 year post-treatment.

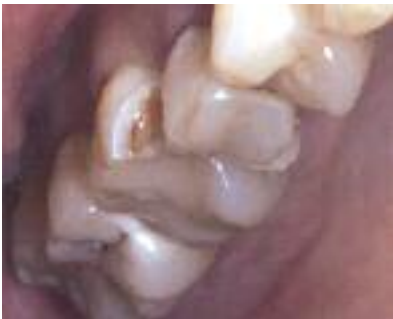
Fig. 12: Preoperative clinical picture showing fracture of tooth # 26
Preoperative radiograph showing deep caries in teeth # 26 and 27 in close proximity to the pulp

A 28 year-old female patient, with free medical history, came after fracture of her first upper left molar (# 26), which occurred during chewing (Fig. 12). Clinical and radiographical examination revealed deep caries at a very high proximity to the pulp in both upper molars (# 26 and # 27) (Fig. 13). Tooth # 26 had already a composite resin filling that was placed 2 years earlier. Clinical examination also showed that both teeth were positive on CO₂ snow sensitivity and negative on percussion. The patient did not mention any previous symptomatology derived from these teeth in her dental history. However, she mentioned that her two lower molars (# 36 and # 46) were endodontically treated due to deep caries that were symptom-free and therefore could not be diagnosed until they reached the pulp cavity. The patient was informed about the need of having the carious lesions treated and the possibility that an endodontic treatment would be required after caries removal.

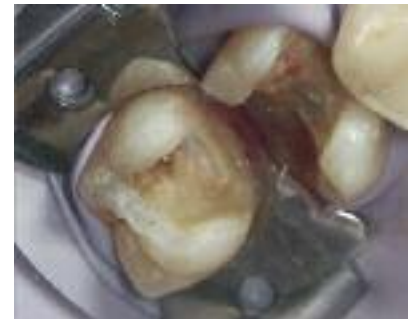
Fig. 14: After caries removal the pulp was exposed iatrogenically in tooth # 26, whereas a very thin pulp facing layer of dentin could be observed in the distal area of 26, as well as the proximal area of 27.

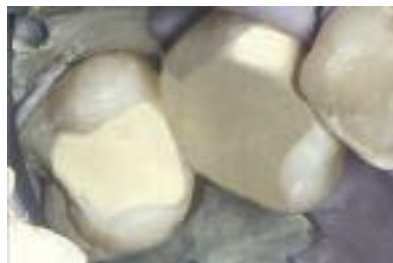
Fig. 16: Biodentine™ was placed as a bulk material to restore both cavities and left in place for 6 weeks. A rubber dam was used to avoid bacterial contamination after pulp exposure

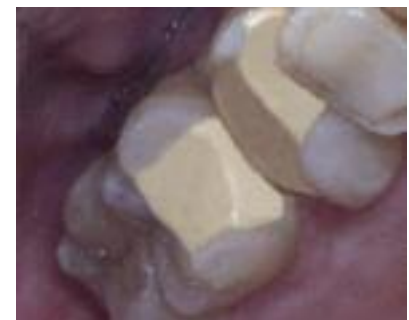
Fig. 17: Biodentine™ restorations after 6 weeks of placement. Marginal integrity of both restorations was fully preserved and no fractures were observed.

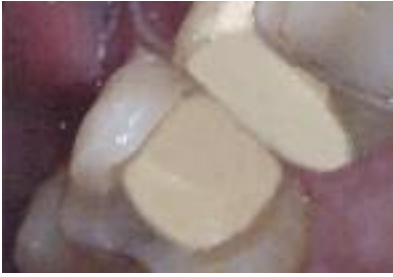
Fig. 18: In tooth # 27 Biodentine™ was then partially removed and kept as a base/dentin substitute that was capped by a direct composite resin filling (Tetric EvoCeram, Ivoclar-Vivadent). Tooth # 26 was prepared for full coverage and Biodentine™ remained as an abutment build-up material.

both teeth remained positive on CO₂ snow sensitivity and negative on percussion. Biodentine™ was then partially removed in tooth # 27 and kept as a base/dentin substitute that was capped by a direct composite resin filling (Tetric EvoCeram, Ivoclar-Vivadent), following normal procedures (acid etching of the cavity with phosphoric acid and application of single step adhesive of the same company) (Fig. 18, 19). Tooth # 26, on the other hand was prepared for a full coverage metal-ceramic crown due to the

significant loss of dental hard tissues after caries removal. The tooth was prepared without removing Biodentine™ that remained and served as an abutment core build-up material (Fig 18). The final metal-ceramic crown was cemented with a conventional GIC (Fuji I, GC) (Fig. 19). At the follow-up visit after 6 months both teeth were free from any symptomatology and again tested positive for sensitivity and negative for percussion. Radiographical examination showed no signs of periapical pathology (Fig. 20).

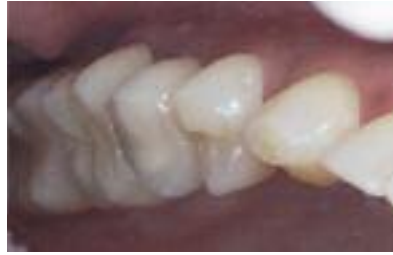
Fig. 19: Post-operative clinical picture with a direct resin composite filling in tooth # 27 and a metal ceramic crown in tooth # 26.

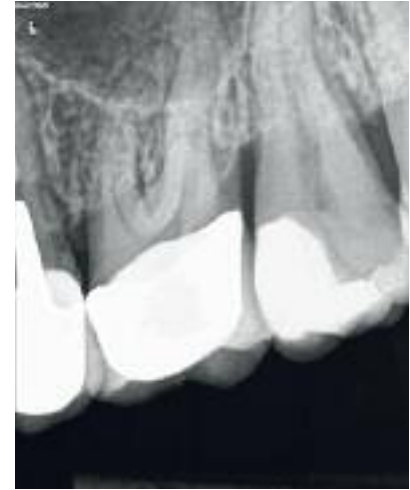
Fig. 20: Radiograph six months post treatment. No signs of periapical pathology could be observed

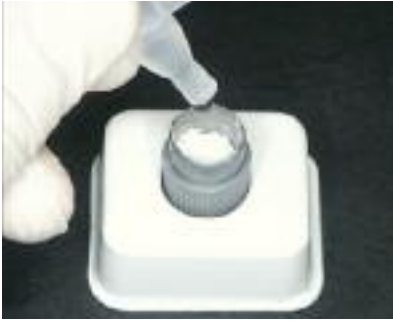
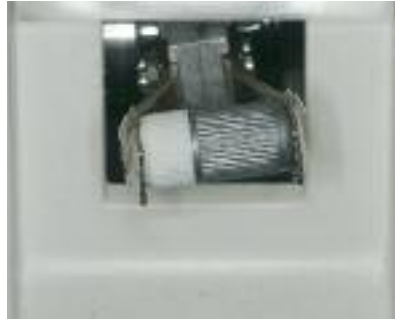
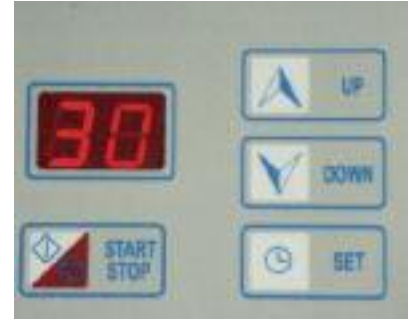
Fig. 21, 22, 23: The material should be handled according to the manufacturer's instructions. It is important to add exactly 5 drops of liquid into the powder capsule and allow it to mix at a speed of 4000 – 4200 rotations/min for 30 seconds.

Although the handling properties of the material present some difficulties, this can be easily overcome by strict compliance to the manufacturer's instructions. It is important to add exactly 5 drops of liquid into the powder capsule and allow it to mix at a speed of 4000 - 4200 rotations/min for 30 seconds (*Fig. 21-23*). In case a lower amount of liquid is added the material is very dry and brittle, whereas a higher amount of liquid will give the material a runny consistency making its handling very difficult. Correctly mixed material must have a creamy consistency (*Fig. 24*). It is also important to allow Biodentine™ to set for at least 12 min before matrix band and wedge

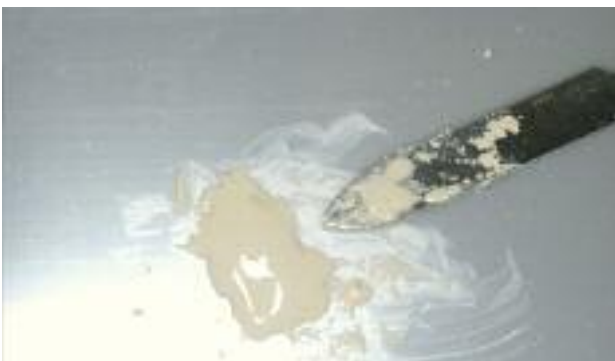
Fig. 24: Correctly mixed material must have a creamy consistency

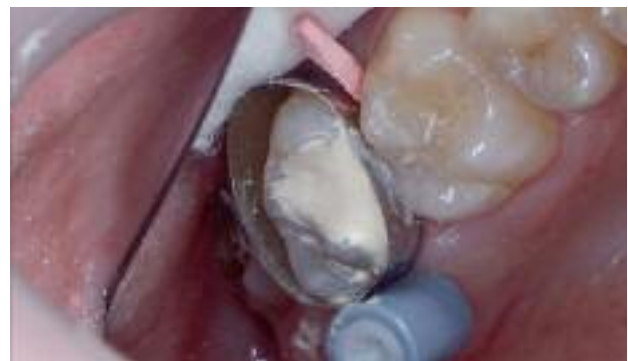
Fig. 25: It is important to allow Biodentine™ to set for 12-15 min before matrix band and wedge removal

removal (*Fig. 25*), otherwise the risk of material fracture is very high. Biodentine™ should not come in contact with liquids during its setting and for this reason application of a rubber dam is mandatory whenever possible. Moreover, the material should be applied into the cavity with light pressure, avoiding excessive carving of the restoration during its setting, because this may disturb its crystalline structure and lead to loss of marginal integrity or fracture. Finally, occlusal adjustment after the material's setting should be performed by light biting on occlusion paper and premature contact removal by a curving hand instrument or excavator and not by rotary instruments.

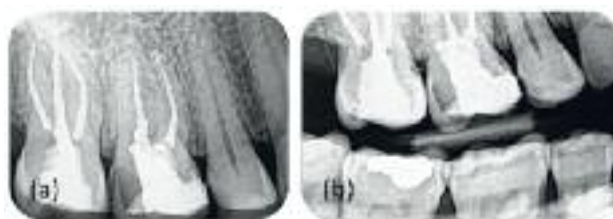
Fig. 1: (a) Periapical radiograph of tooth #3 revealed a previous endodontic treatment and a possible missed disto-buccal root canal. (b) Bite-wing radiograph provided more precise information about the condition of the pulp chamber.

tooth # 3 revealed composite restoration, previous endodontic treatment with no signs of periapical radiolucency, and a possible missed root canal in the distal root (*Fig. 1a, b*). Based on the clinical and radiographic findings, symptomatic apical periodontitis was diagnosed and endodontic retreatment scheduled.

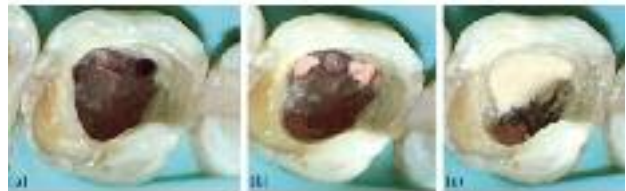
Fig. 4: (a,b) Location of the furcal perforation. (c) Biodentine™ within the access cavity.

We dried the furcal perforation with a cotton pellet and packed Biodentine™ into the defect (*Fig. 4a-c*). A hand plugger was used to gently accommodate Biodentine™ inside the defect. Biodentine™ was mixed according to the manufacturer's instructions and allowed to set for 12 min. An endodontic sponge was placed on the set Biodentine™ and the access cavity temporized with IRM® (Dentsply De Trey GmbH,

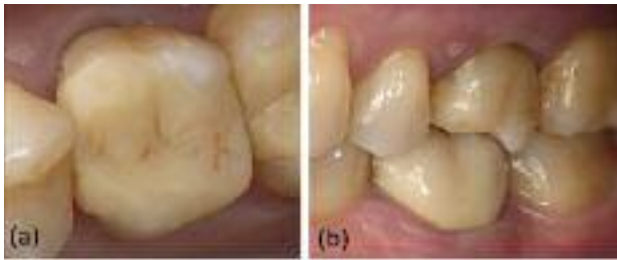
Fig. 6: (a) Tooth #14 with composite resin overlay. (b) Lateral view of tooth #14.

contained no abnormal data. On examination the tooth showed a composite resin overlay (*Fig. 6a,b*). Clinically, the tooth was negative to palpation and percussion; radiographic examination revealed incomplete root canal fillings and signs of periapical radiolucency (*Fig. 7a-c*). Having diagnosed an asymptomatic apical periodontitis we suggested non-surgical treatment. Informed consent was obtained from the patient, and a small volume CBCT was taken using ProMax 3Ds (Planmeca OY, Helsinki, Finland) to reveal the exact location of the untreated root canals. The tooth involved was pinpointed, and the morphology was obtained in coronal, axial and sagittal sections of 0.5mm thickness. The axial and coronal images showed the presence of the mesio-buccal and disto-buccal root canal, as well as a furcal perforation (*Fig. 8a,b*).

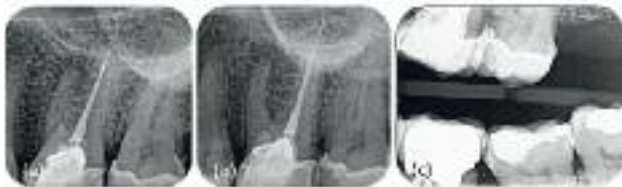
Fig. 7: (a,b) Pre-operative periapical radiographs (parallax technique) with different horizontal angulations. (c) Bite-wing radiograph.

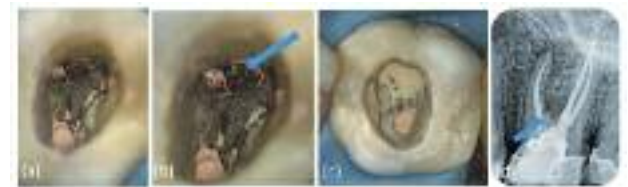
Fig. 10: (a-c) The perforation (blue arrow) of the pulp chamber floor was covered with Biodentine™. (d) Post-operative periapical radiograph taken immediately after completion of the root canal retreatment and the placement of Biodentine™.

(Dentsply Maillefer, Ballaigues, Switzerland). Gutta-percha cones were used to confirm working lengths (*Fig. 9c,d*). Canal preparation was accompanied by copious irrigation with 4.2% sodium hypochlorite, followed by a final flush with 17% EDTA for 2 minutes and neutralized with 4.2% sodium hypochlorite. The final flushing of the root canals with sodium hypochlorite was performed with ultrasonic passive irrigation for 1 minute. After final irrigation, the root canals were filled using Sytem B heat source (EIE/Analytic Technology, Richmond, WA, USA) (*Fig. 10a,b*). Then, the perforation was dried and Biodentine™ was packed into the defect and allowed to set for 12 min (*Fig. 10c,d*). Finally, we placed zinc oxide-eugenol material (IRM® cement; Dentsply De Trey GmbH, Konstanz, Germany) above the Biodentine™ to prevent its displacement.

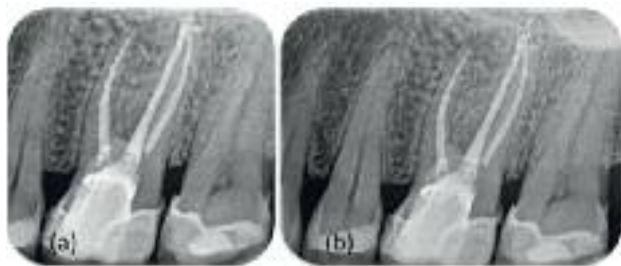
Fig. 11: (a,b) At 12 months, the radiographic examination revealed a successful resolution of the periradicular lesion.

12-month recall examination and periapical radiographs showed a successful resolution of the periradicular lesion (*Fig. 11a, b*).

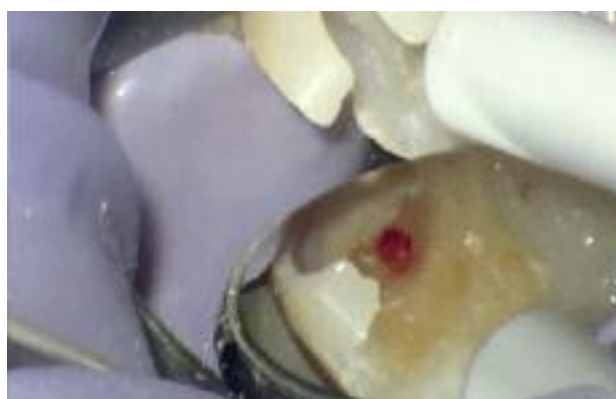
Fig. 2

Local anaesthetic was administered, the tooth isolated with rubber dam and the caries excavated which revealed an exposure of the distal pulp horn (*Fig. 2*) with normal vital pulp tissue. The cavity was irrigated with 3% sodium hypochlorite for 30 seconds and then rinsed thoroughly with copious amounts of sterile water. The cavity was then dried taking care to not desiccate the pulp.

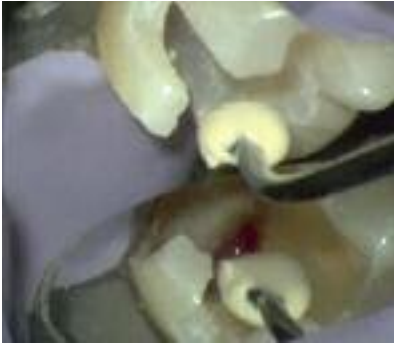
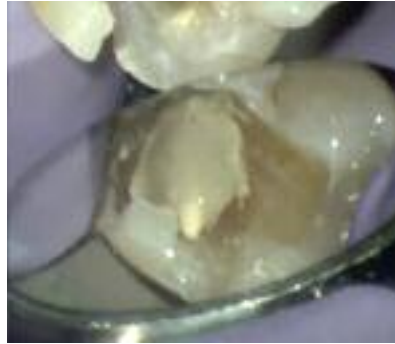
Fig. 3

Biodentine™ was mixed according to the manufacturers' instructions and using a Thymozin instrument a thin layer of material was placed

over the exposed pulp taking care to avoid creating pressure on the pulp. (*Fig. 3 & 4*) This
